NASA TN D-4881

NIMBUS II FLIGHT EVALUATION AND ENGINEERING REPORT, LAUNCH THROUGH ORBIT 5275

*Joseph J. McNaney and Bennie A. Palmer
General Electric Company*

*Ralph Shapiro
Goddard Space Flight Center*

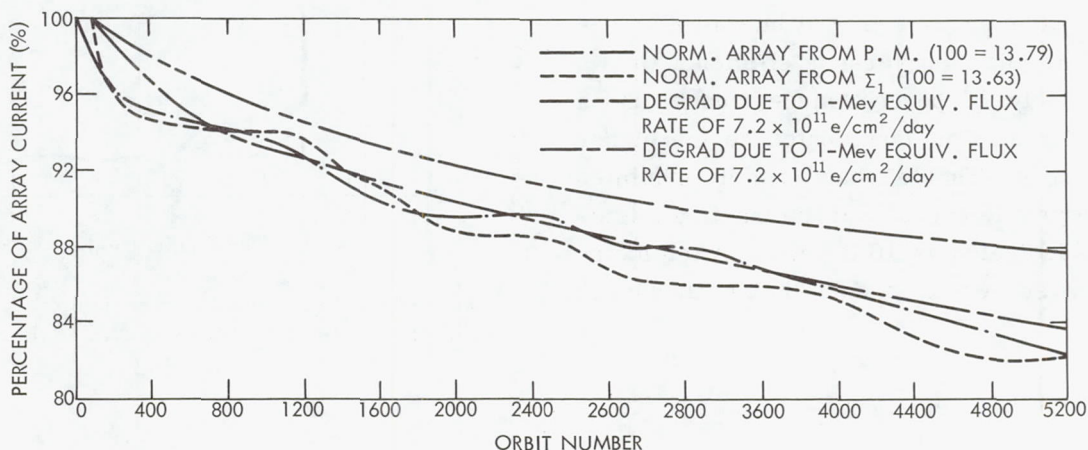
Figure 4-8 is a time history of the normalized solar array average output indicating the degradation of the array. The normalized array output is shown for an estimated degradation caused by two levels of flux (7.2×10^{11} and 9.4×10^{11} e/cm²/day).

The plot based on power management calculations indicates a large drop probably caused by ultraviolet degradation. Preflight expectations (Reference 3) were that the initial drop would level off at 4 percent after 100 hours (60 orbits). At orbit 100, the drop was approximately 2 percent and leveled off at 6 percent at orbit 500. The array output based on the summation-of-current methods indicated less than 1-percent drop in 200 orbits, followed by a sharp drop, again leveling off at approximately 6 percent at orbit 500. Thereafter, both techniques show the same trend. The significance of the irregular degradation pattern is uncertain; it may be caused by errors in

Figure 4-8—Degradation of normalized solar array.

determining average array output, or it may be caused by short-term, cyclic variations in the flux rate or errors in normalizing for the board failures after orbit 1000. Two fixed corrections were used during the orbit when the failures occurred, although telemetry data indicated that, after the second array board failure, some output was still obtained from the board for some portion of the orbit. The loss of the PCM tape recorder in orbit 949 made a quantitative understanding of this phenomenon very difficult. Any intermittent output would therefore make the normalized array output plot be irregular and show high points. Refer to the paragraphs under Solar Cell Experiment for a description of the degradation of the two solar cell experiments.

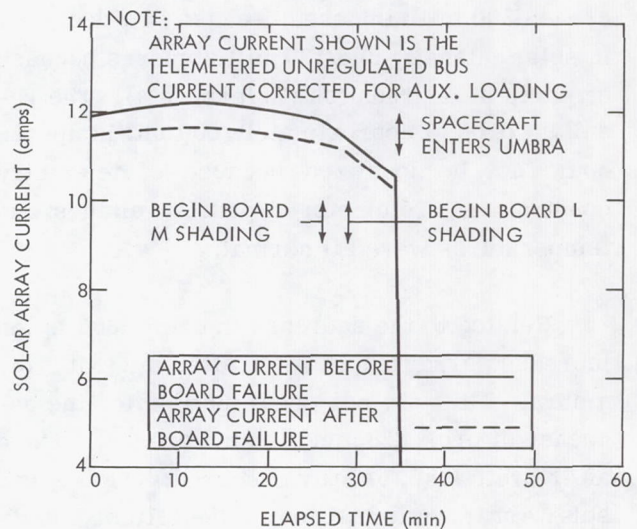
Between orbits 1065 and 1070, the solar array output dropped from a level of 12.5 to 11.9 amperes. Spacecraft attitudes were verified to be normal, and the solar array drive was operating properly. Paddleboards M and L, located on the left-hand paddle (the paddle on the left side of the spacecraft when one is looking along the velocity vector) are normally shaded by the sensory ring (with a positive β angle) before entering and after leaving the umbra. This condition was verified by a distinct pattern of decreased solar array output at these points in the orbit.

A comparison of the solar array current output trailoff (before entering the umbra) before and after the drop in total output is shown in Figure 4-9. From the figure it can be seen that the telemetered value of array current (after the board failure) averaged approximately 700-milliamperes lower before shading and approximately 0.2 amperes lower during maximum shading than it did before the failure. Assuming that all cells delivered the same amount of current, board L (with 980 cells) and board M (with 582 cells) would provide 1.04 amperes and 0.645 amperes, respectively, based on the telemetered array current value of 12.2 amperes (sensor reading plus auxiliary load losses). The decrease (approximately 600 milliamperes) compares favorably with the 645 milliamperes that would be provided by board M. From Figure 4-9 it is noted that, since the failure, shading does not affect the total output until approximately 5.5 minutes before entering the umbra, whereas before the failure it affected the output up to 3 minutes earlier. The reason for this is that board M, because of shading, is affected normally before board L (because of the manner in which the shading occurs; see Figure 4-10). Therefore, if board M has failed, the dropoff would be delayed (Figure 4-9).

The 200-milliampere difference during the period of maximum shading may be attributed to telemetry resolution of the unregulated bus sensor, which is approximately ± 150 milliamperes in the 10- to 12-ampere range. No voltage telemetry is available on either board M or board L; voltage telemetry on boards A, F, G, and J was normal.

Figure 4-9—Shading effects on solar array output before and after paddleboard failure.

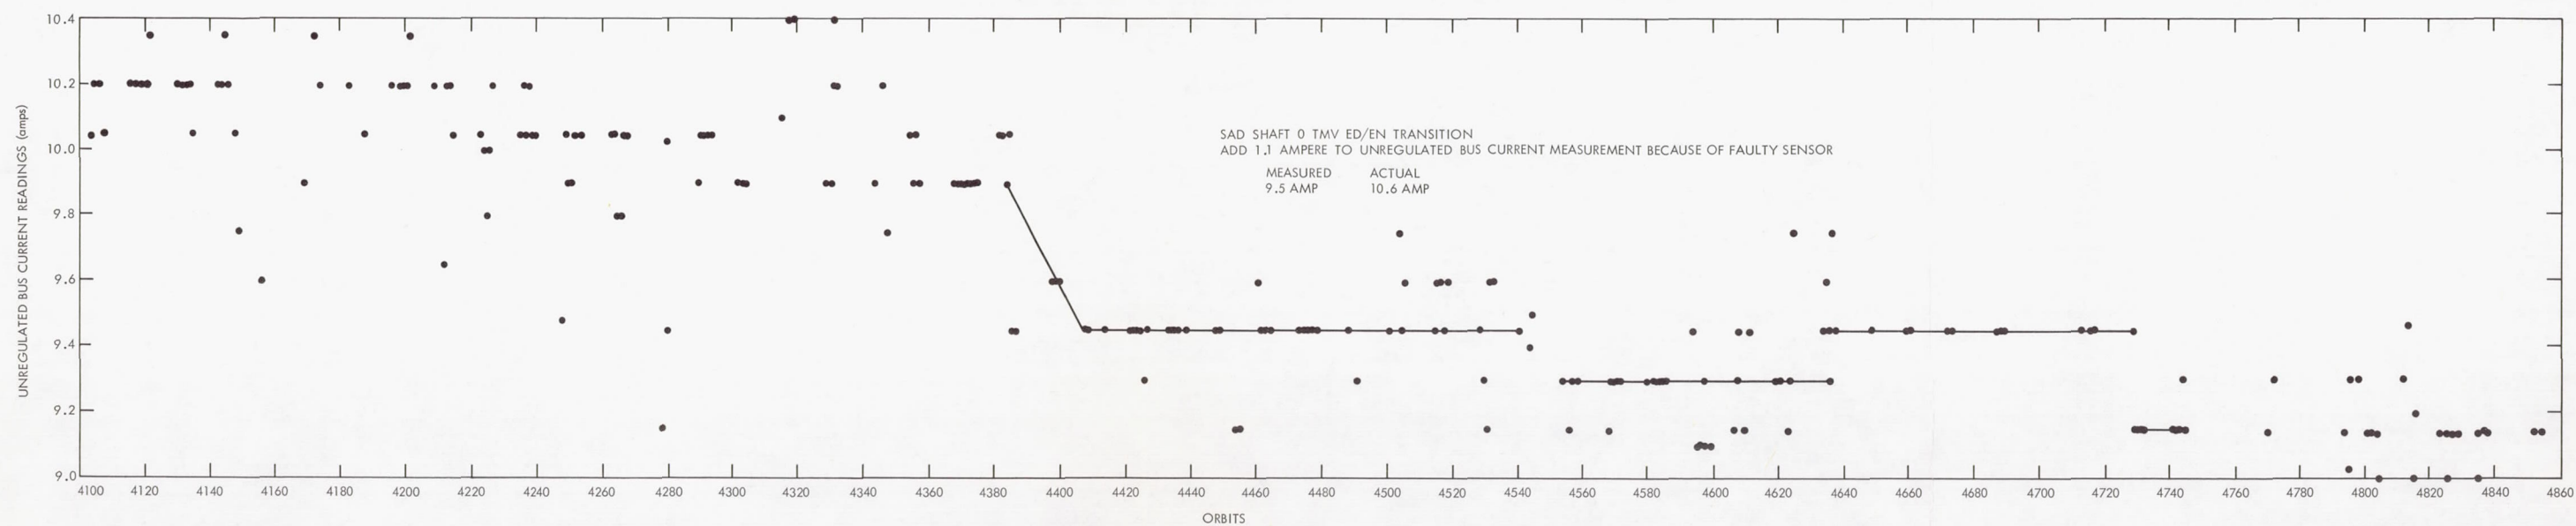
The solar array output decreased by approximately 600 milliamperes between orbits 4384 and 4386. Figure 4-11 is a plot of the unregulated bus current before and after the decrease. The array output dropped approximately 1.00 ampere between orbits 4000 and 4700. During this interval, the output was expected to decrease 300 milliamperes because of a decrease in solar intensity and 100 milliamperes because of particle degradation (Reference 4). The resultant drop of approximately 600 milliamperes could not be localized because of telemetry constraints. Telemetered paddle voltages and temperatures were all normal.

Figure 4-11—Unregulated bus history during second paddleboard failure.

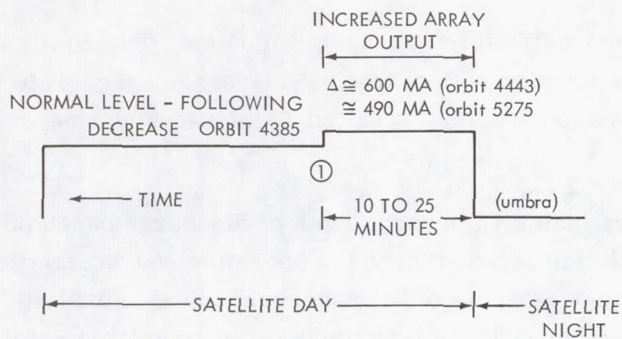
Related to the decrease in orbit 4386 is the increased array output noted after the exit from umbra. This did not occur until after the decrease of orbit 4385 and is still present. The drop (Figure 4-12) to the normal value, established after orbit 4385, usually occurred: (1) with paddle temperature between 7°C and 23°C; (2) with solar array shaft position between 10 and 30 degrees; and (3) with the spacecraft within ± 10 minutes of the earth night-to-day transition. The initial magnitude of the increase was approximately 600 milliamperes (orbit 4443) and is presently approximately 490 milliamperes (orbit 5275). Examination of available telemetry has revealed no additional information. The most probable cause is thermal cycling of the associated panel board failure in orbit 4385.

Figure 4-12—Increased array output following transition from satellite night to satellite day.

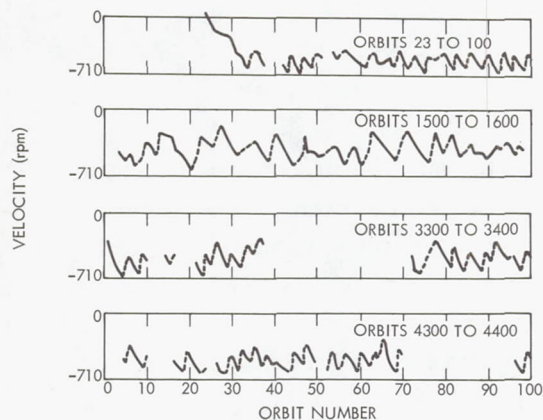
Since orbit 13, a nearly constant negative pitch disturbance torque caused the pitch flywheel to absorb momentum continuously. Each third or fourth orbit, as the pitch flywheel speed approached -900 rpm, the torque caused by accelerating the solar array to the maximum slew rate (upon entering the earth's umbra) induced a negative pitch error that, in turn, caused the flywheel to attain gating speed. Following the solenoid gate, the flywheel speed was reduced to approximately -400 rpm, thus beginning the momentum buildup cycle again (Figure 5-9). Occasionally, the flywheel did

Figure 5-9—Pitch velocity profile.

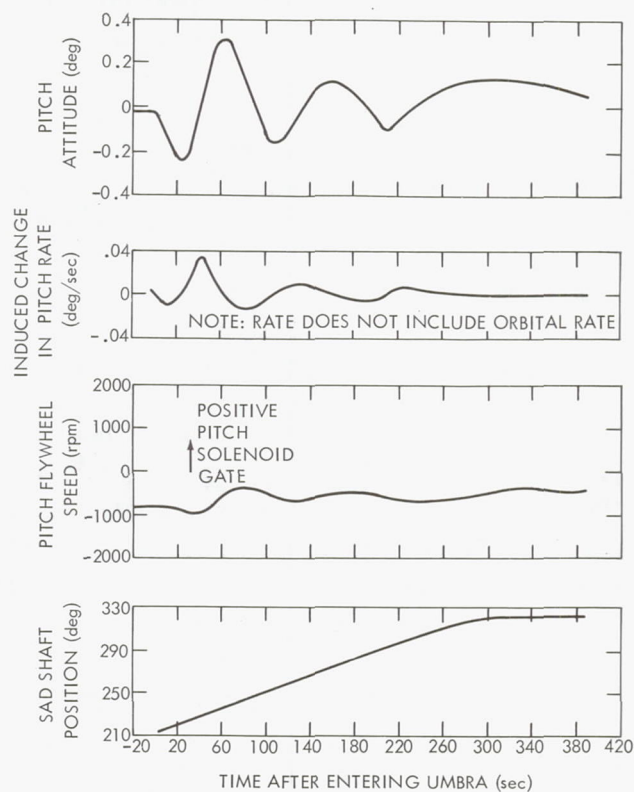
The pitch disturbance that occurred during the satellite day-to-night transition period is illustrated in Figure 5-10. This figure shows that the pitch flywheel was capable of overcoming the negative pitch error. However, since

Figure 5-10—Pitch stabilization control characteristics during transition from satellite day to satellite night (orbit 1220).

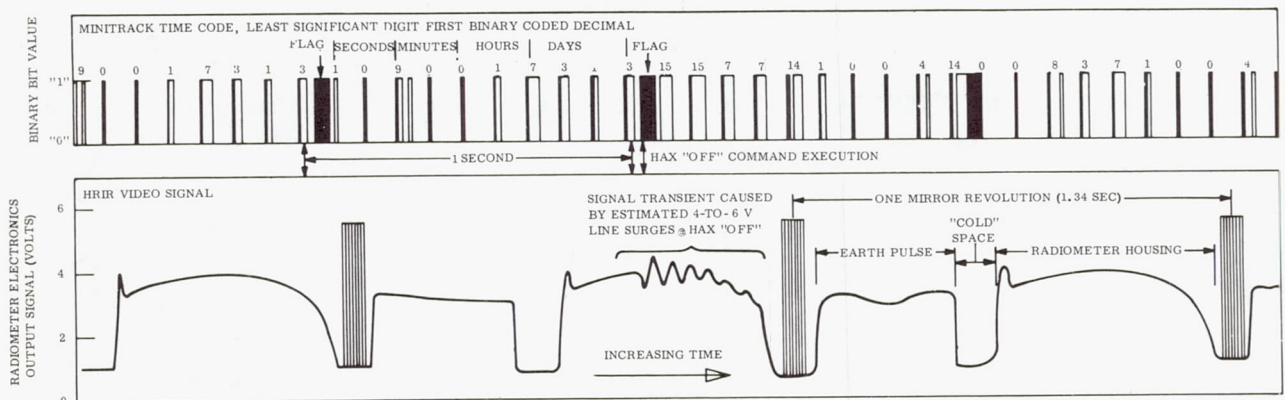
The first clock upset occurred at the time of spacecraft/Agenda separation as anticipated. A high-speed Visicorder chart was used to extract telemetry data in raw form from the Johannesburg real-time data tape for this time period. No significant transients in regulated bus current or voltage was observed. However, the low sampling rate of the spacecraft telemetry in all probability precluded observation of transients. The short duration of the voltage transient is further substantiated by the fact that feedback amplifier switching did not appear to have occurred. The transient at unfold squib-firing was probably a damped oscillation of insufficient duration to cause switching, as was the situation for orbit 28U (Figure 7-5).

Figure 7-5—Visicorder record of HRIR video signal and minitrack time code at HAX turn-off (Ulaska-station pass orbit 28).

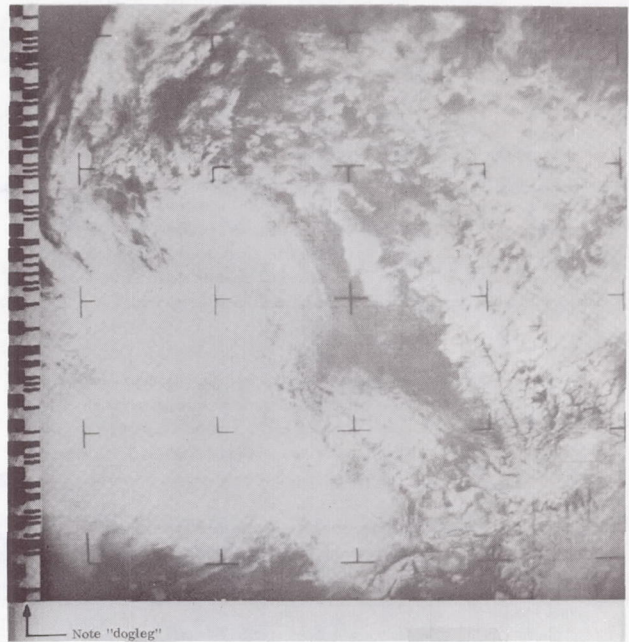
Figure 7-7—APT subsystem photograph showing "dogleg" in the data code and grid.

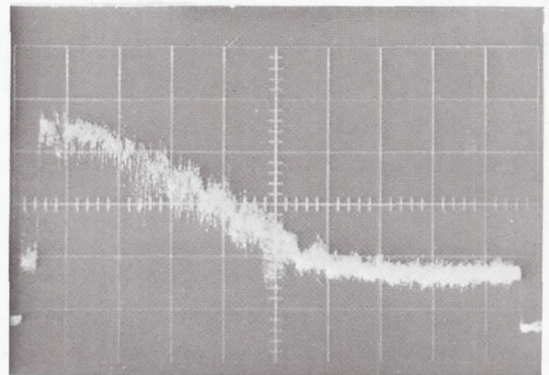
FLASH TUBES OF CAMERA 1 BECAME
INTERMITTENT (orbit 3250) AND
SUBSEQUENTLY FAILED

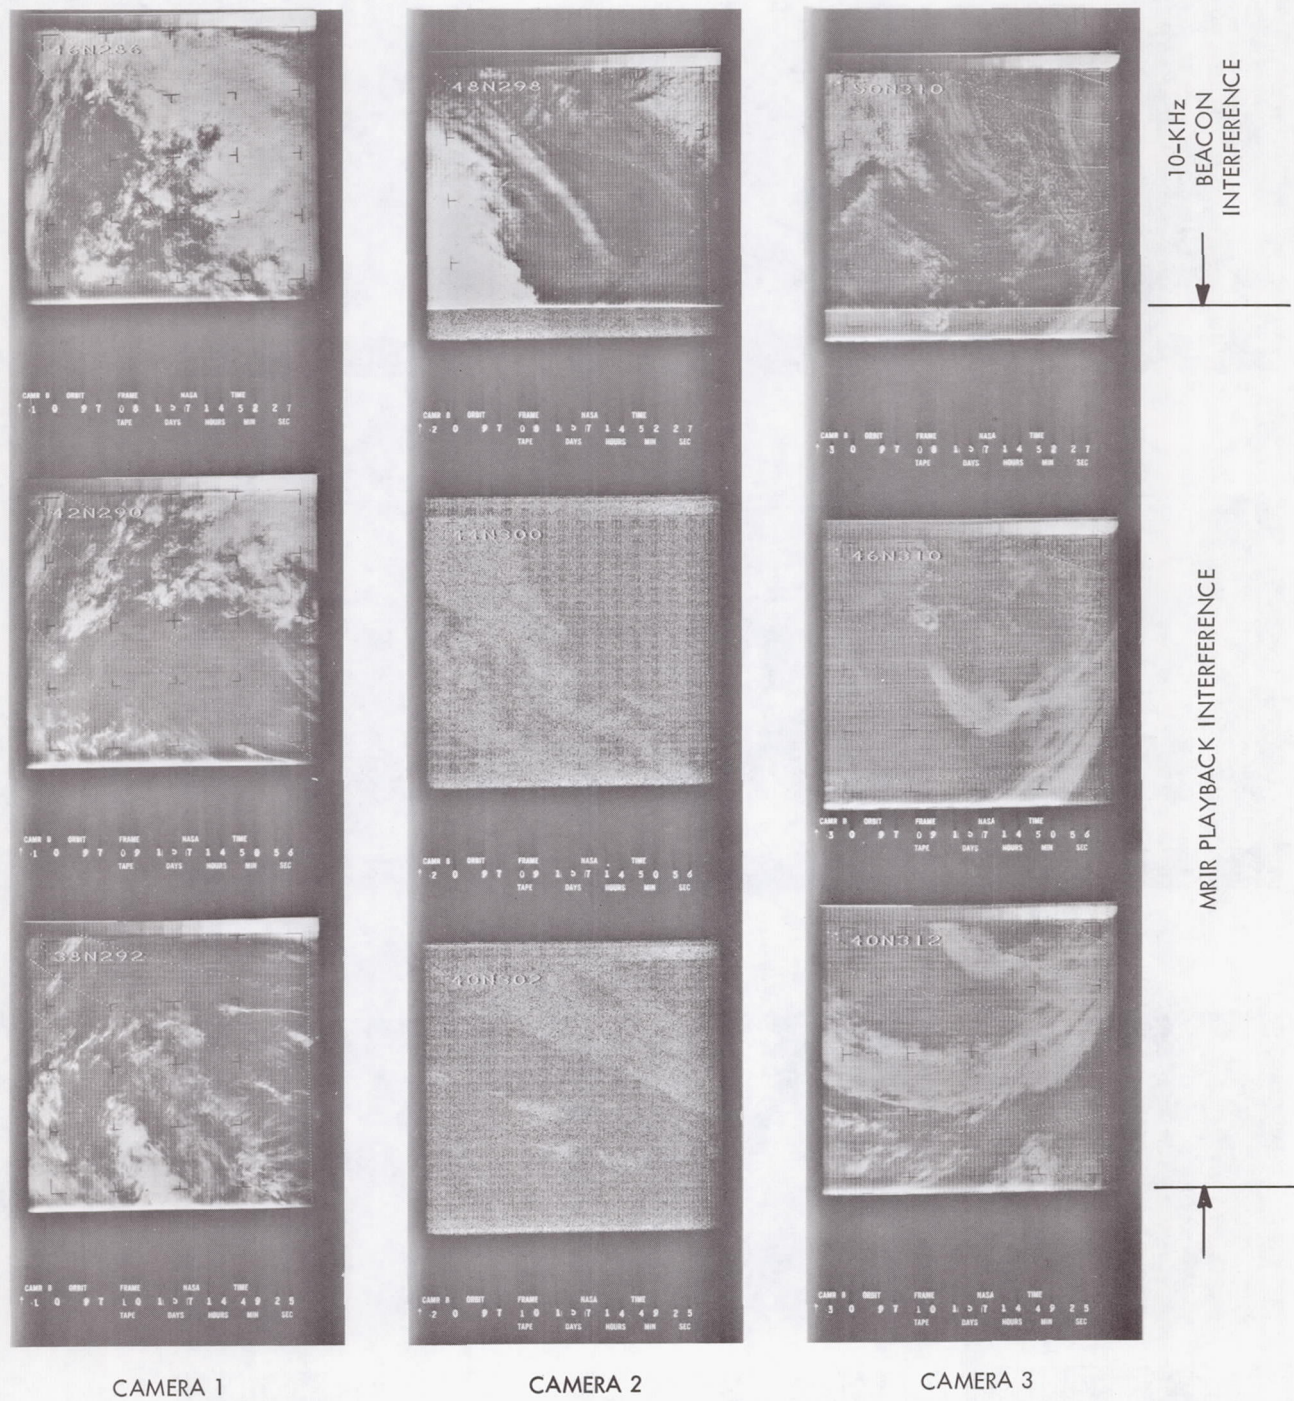
Figure 9-16—AVCS photographs of MRIR transmitter interference patterns.

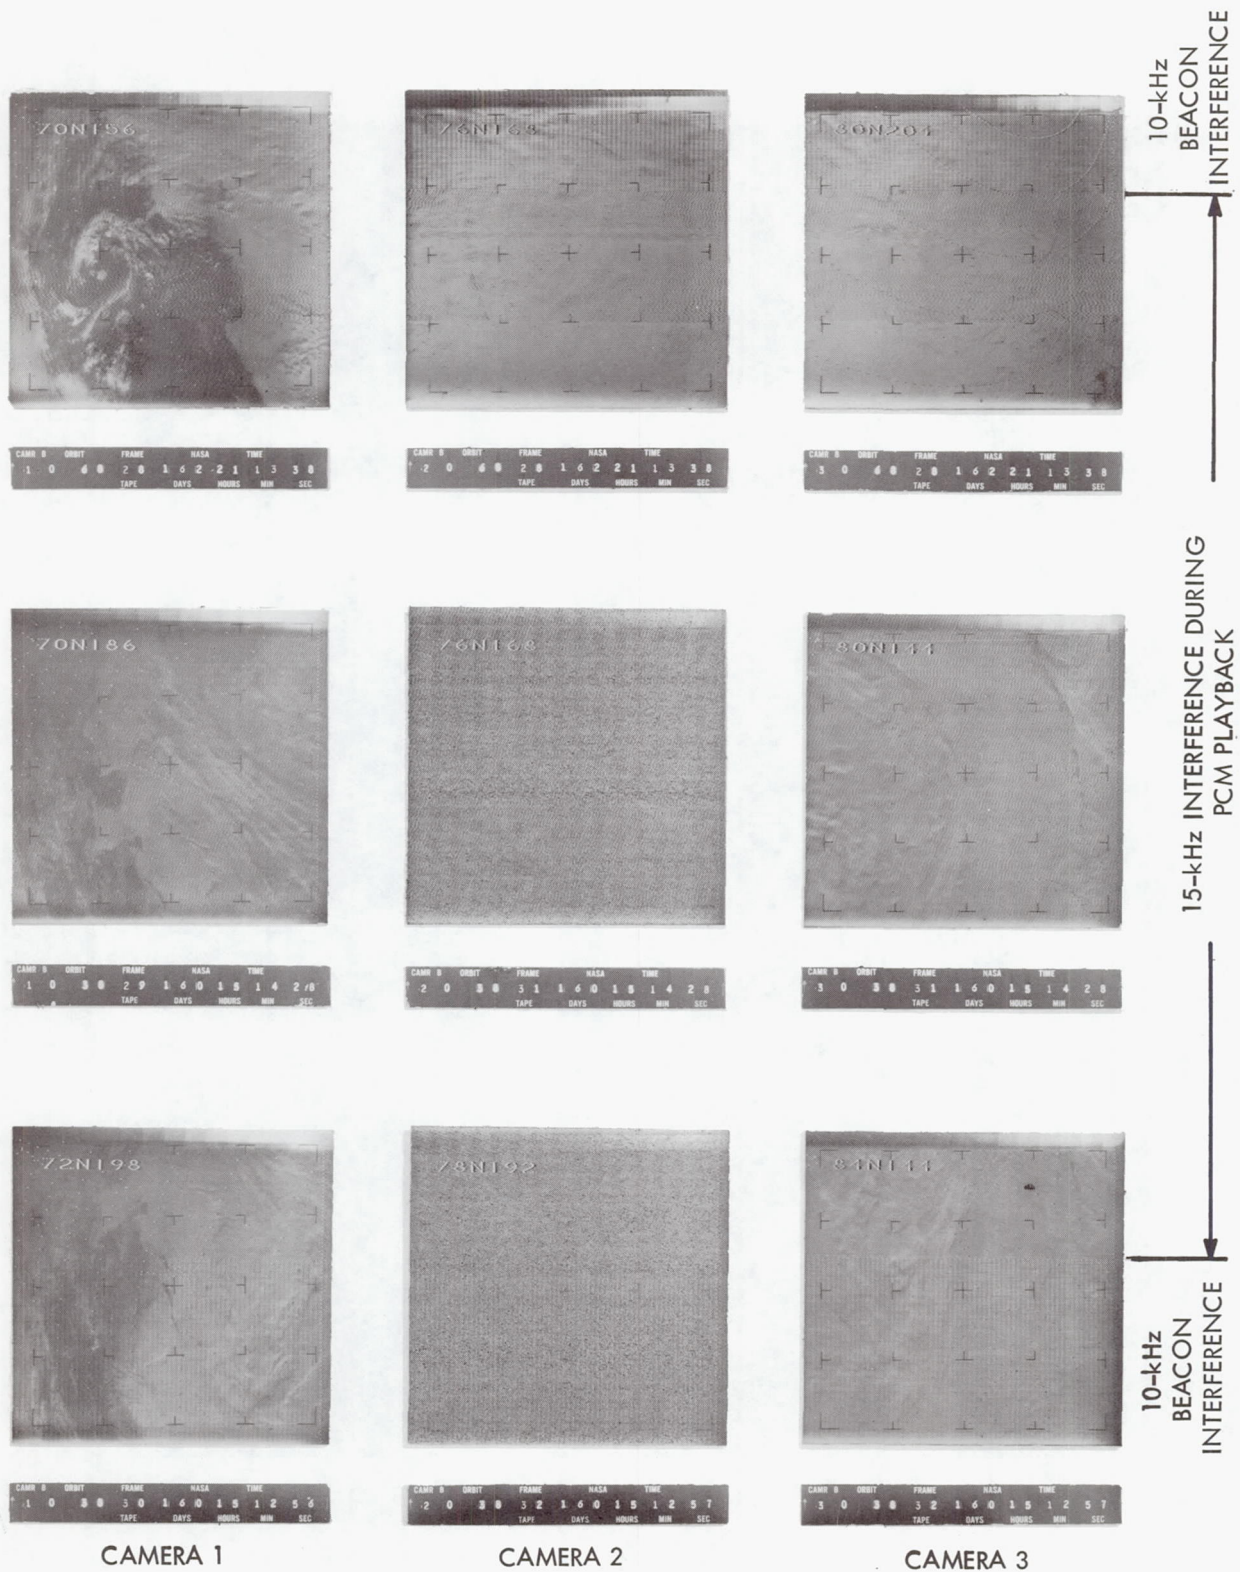
Figure 9-17—AVCS photographs of PCM Beacon transmitter interference patterns.

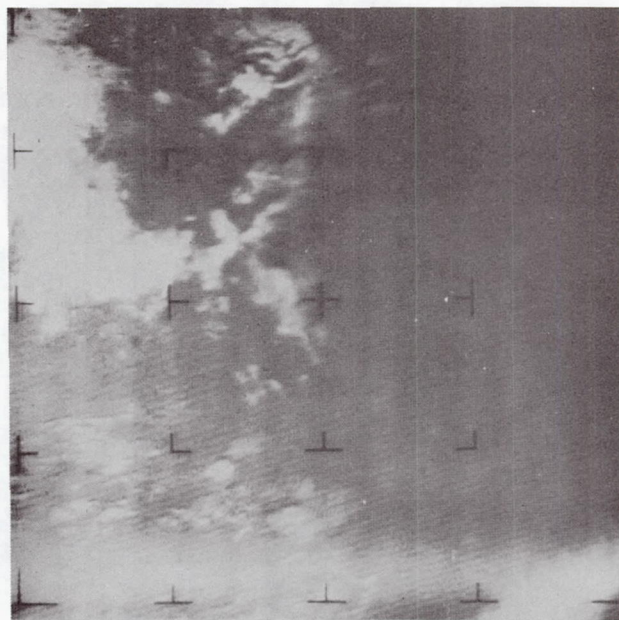
Figure 9-21—AVCS photograph showing APT subsystem transmitter interference. Shaded vertical bars, thought to be interference from 2400-Hz APT subsystem AM subcarrier during orbit 4399. Diagonal interference pattern in lower portion of photo is microphonics resulting from mechanical vibration of the internal elements of the vidicon.

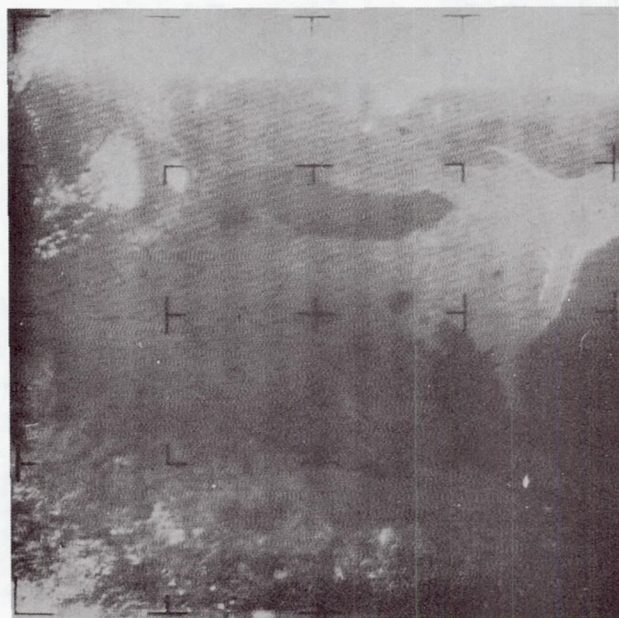
Figure 9-22—AVCS photograph showing 50-kHz timing signal interference.

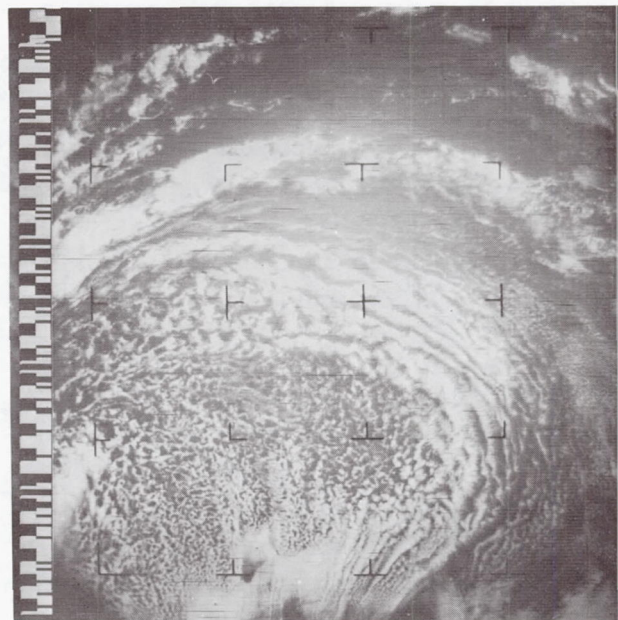
Figure 10-12--APT subsystem photograph (orbit 4438) showing shift in transfer characteristics as a result of alteration of the processor.

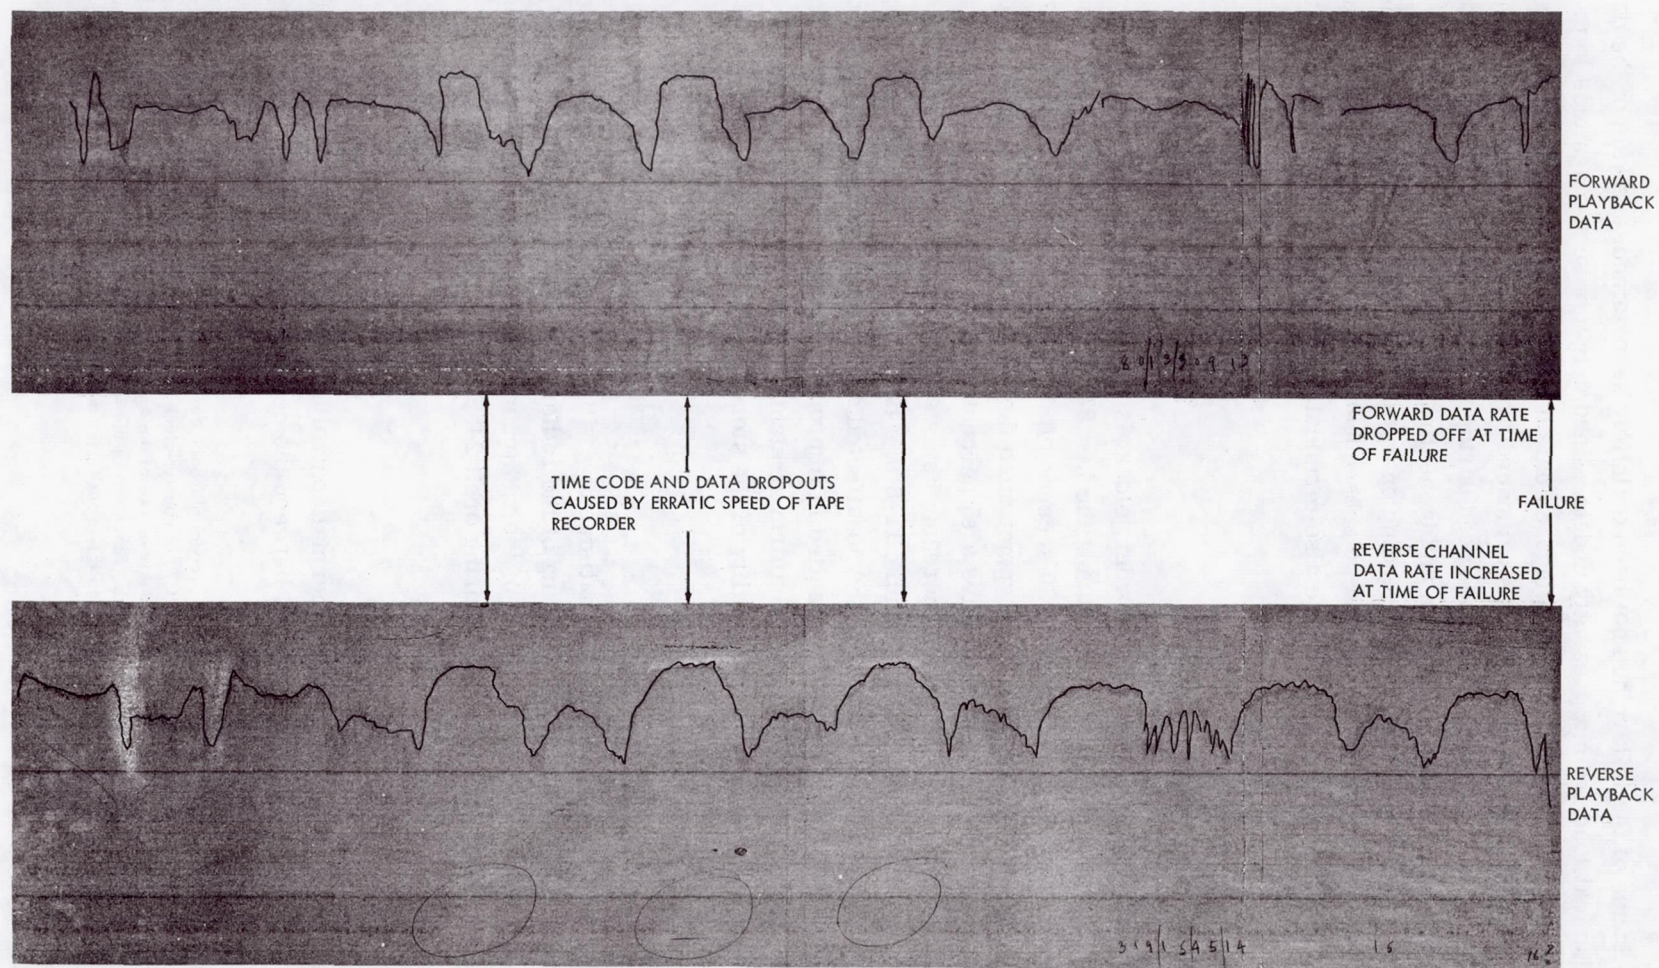
Figure 11-6—Visicorder presentation of HRIR recorder failure data (orbit 2455).

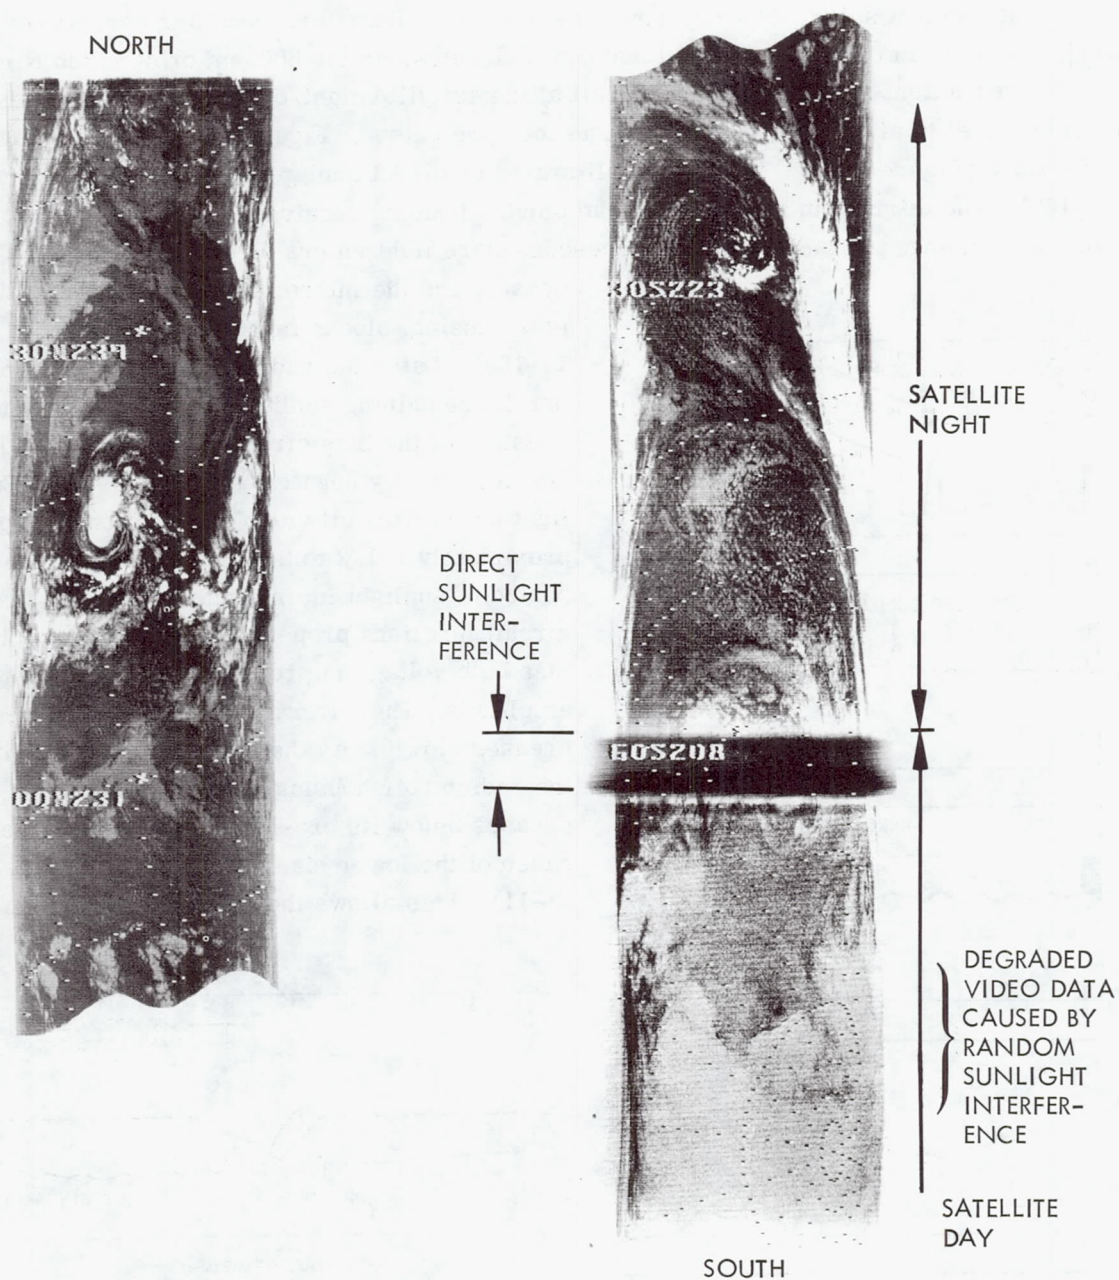
Figure 11-12—HRIR video data showing degradation caused by incident solar radiation.

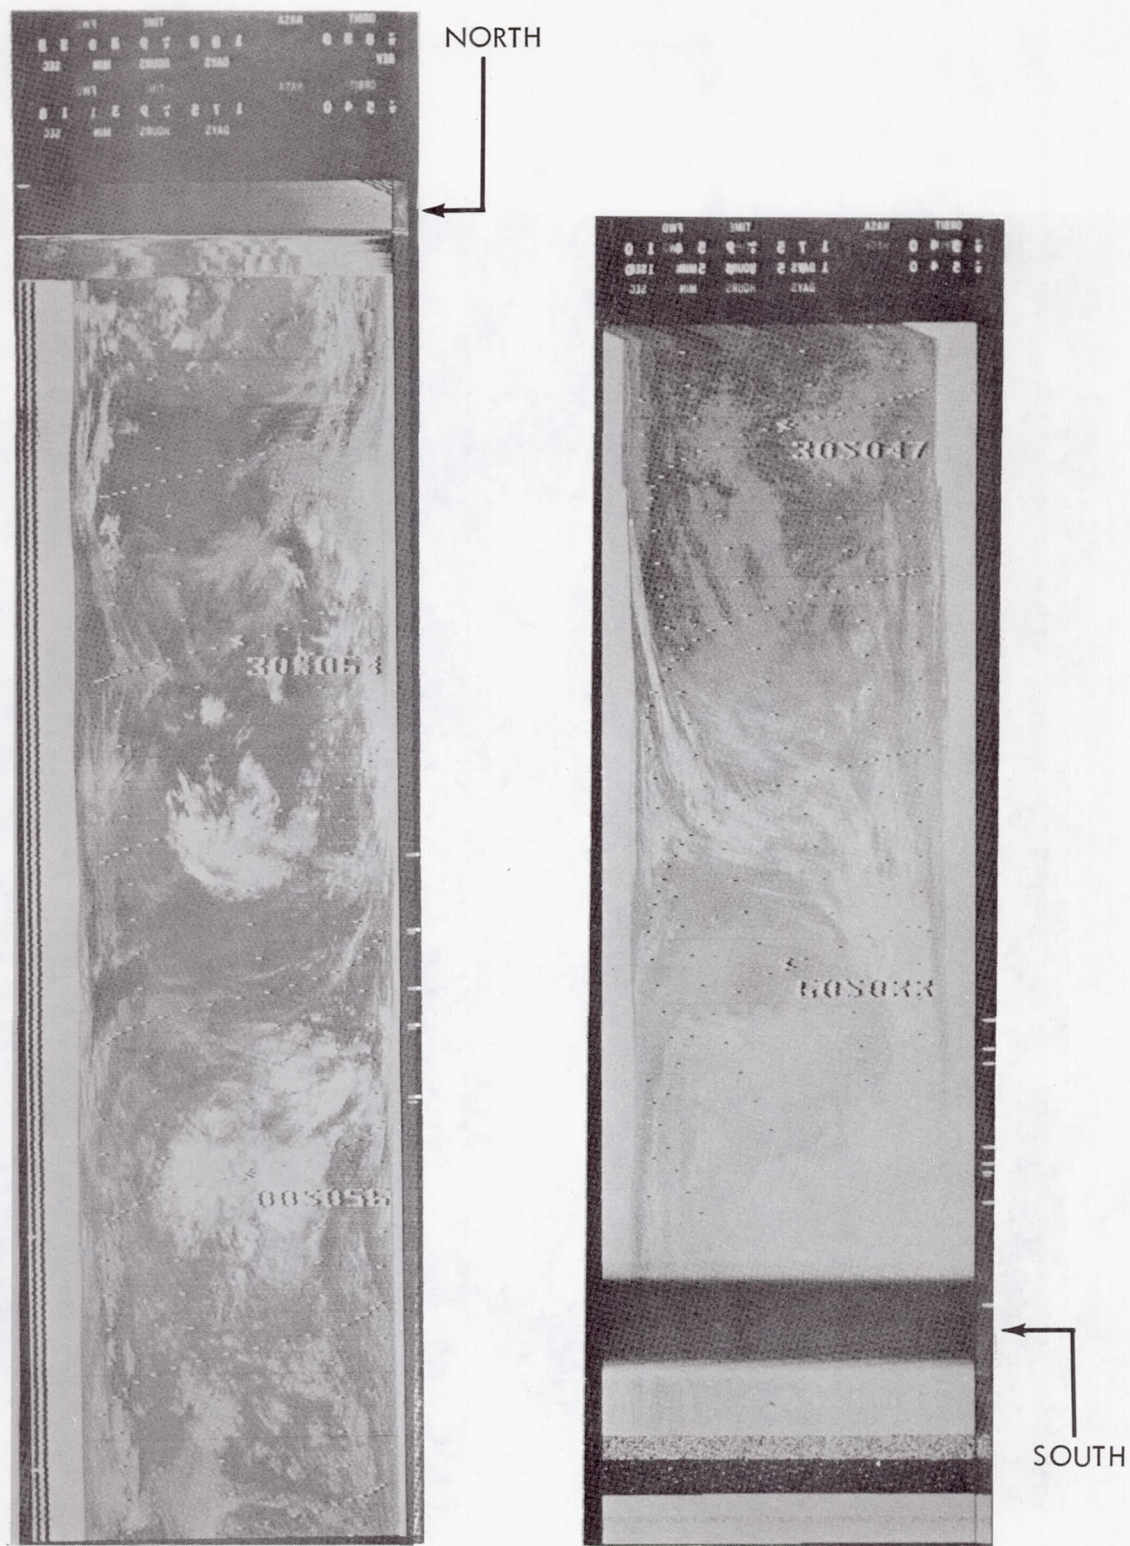
Figure 11-14—HRIR video data showing degradation of signal-to-noise ratio caused by elevated detector cell temperature (South Pole vicinity, orbit 5400).

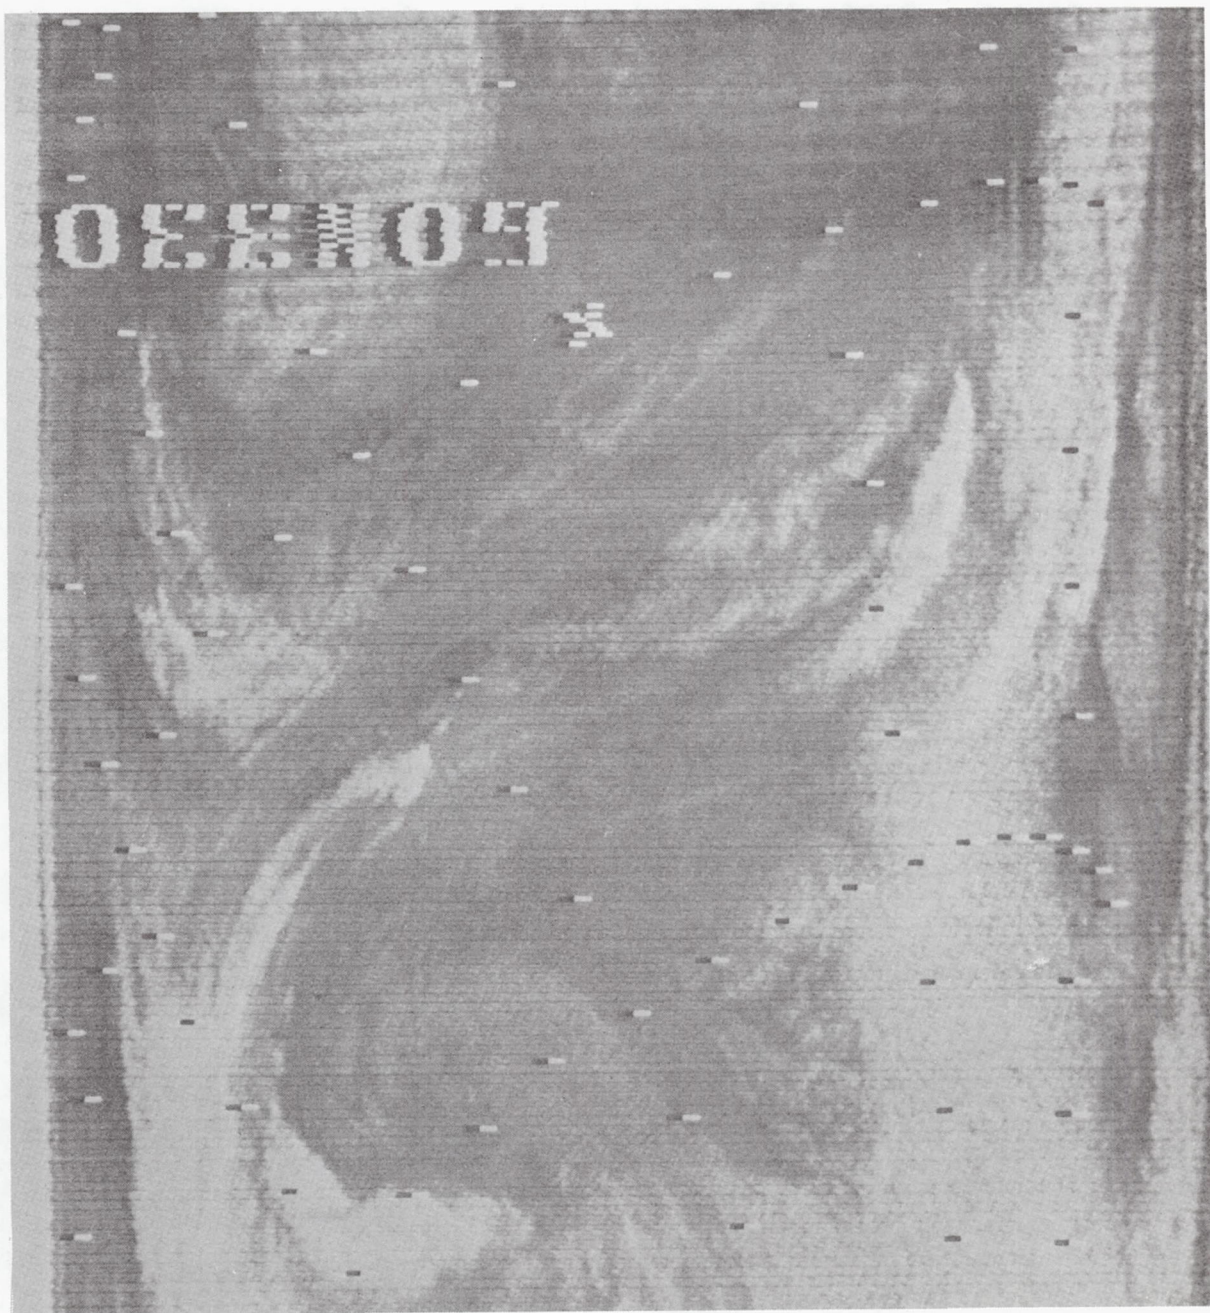
Figure 11-15—HRIR photograph showing 200-Hz interference (faint diagonal lines).

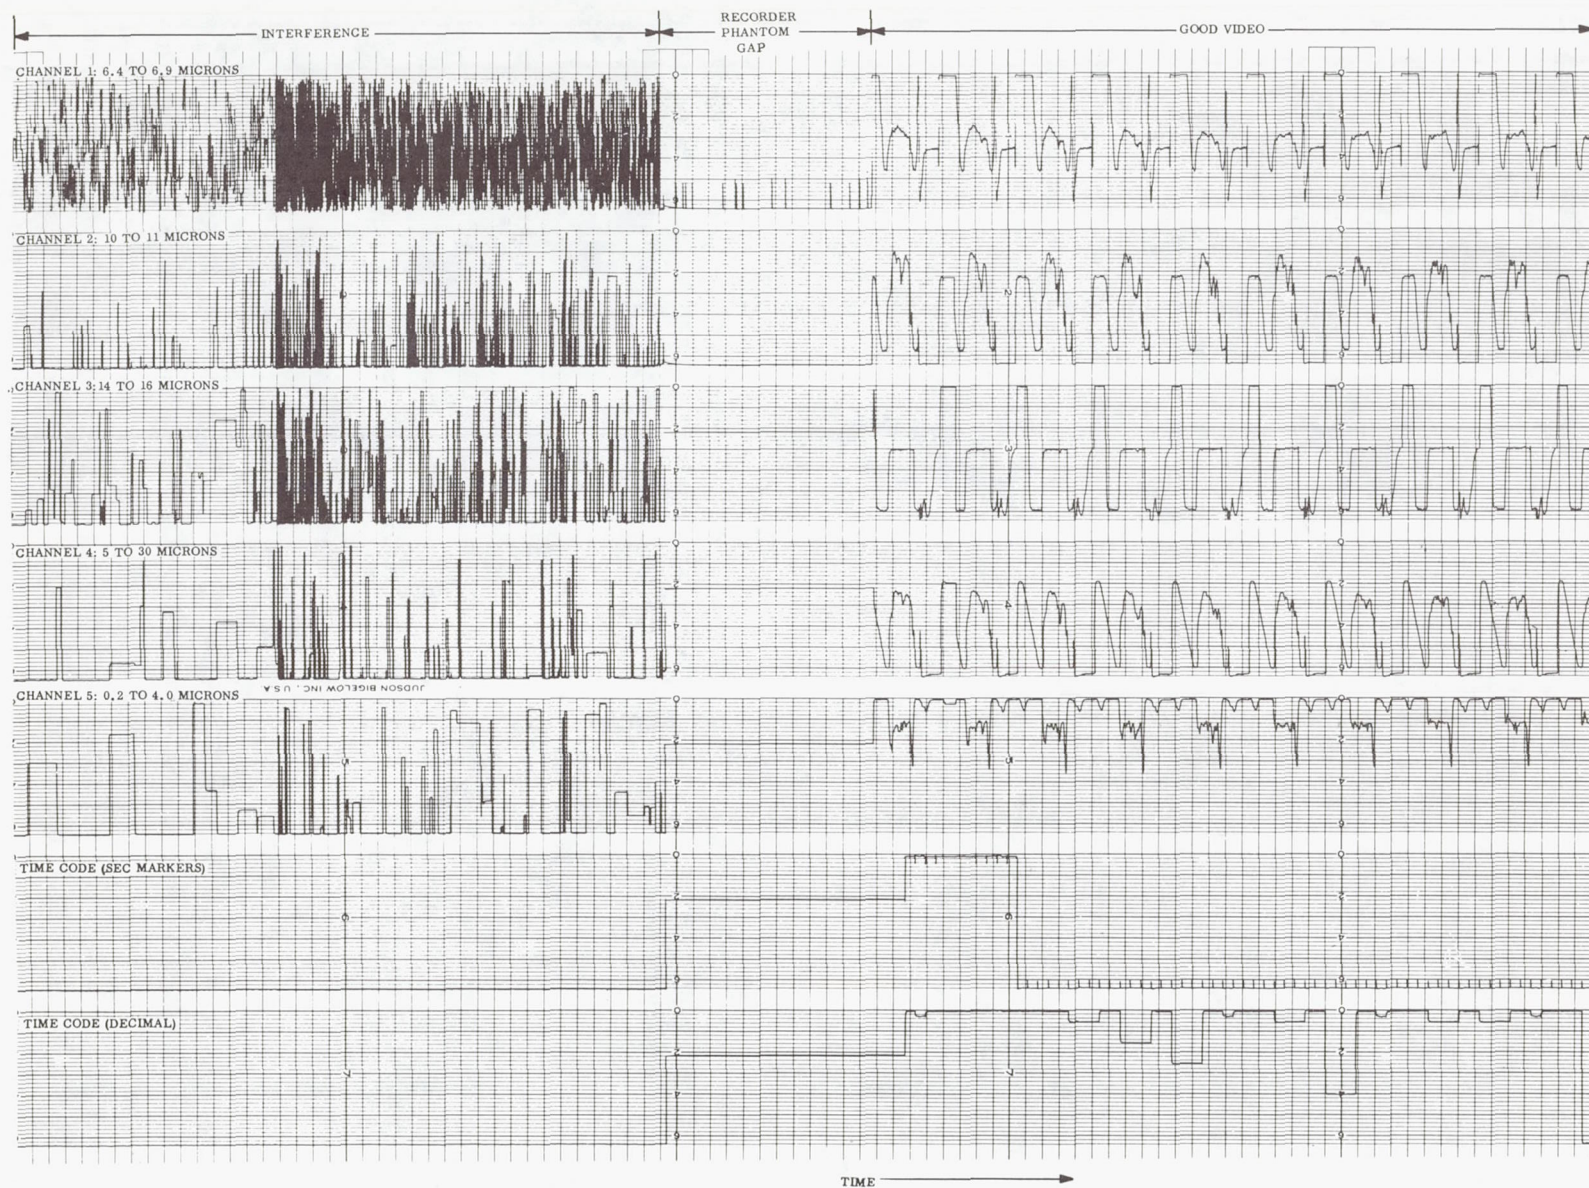
Figure 12-4—MRIR video brush recording showing APT subsystem interference at ground-station receiver.

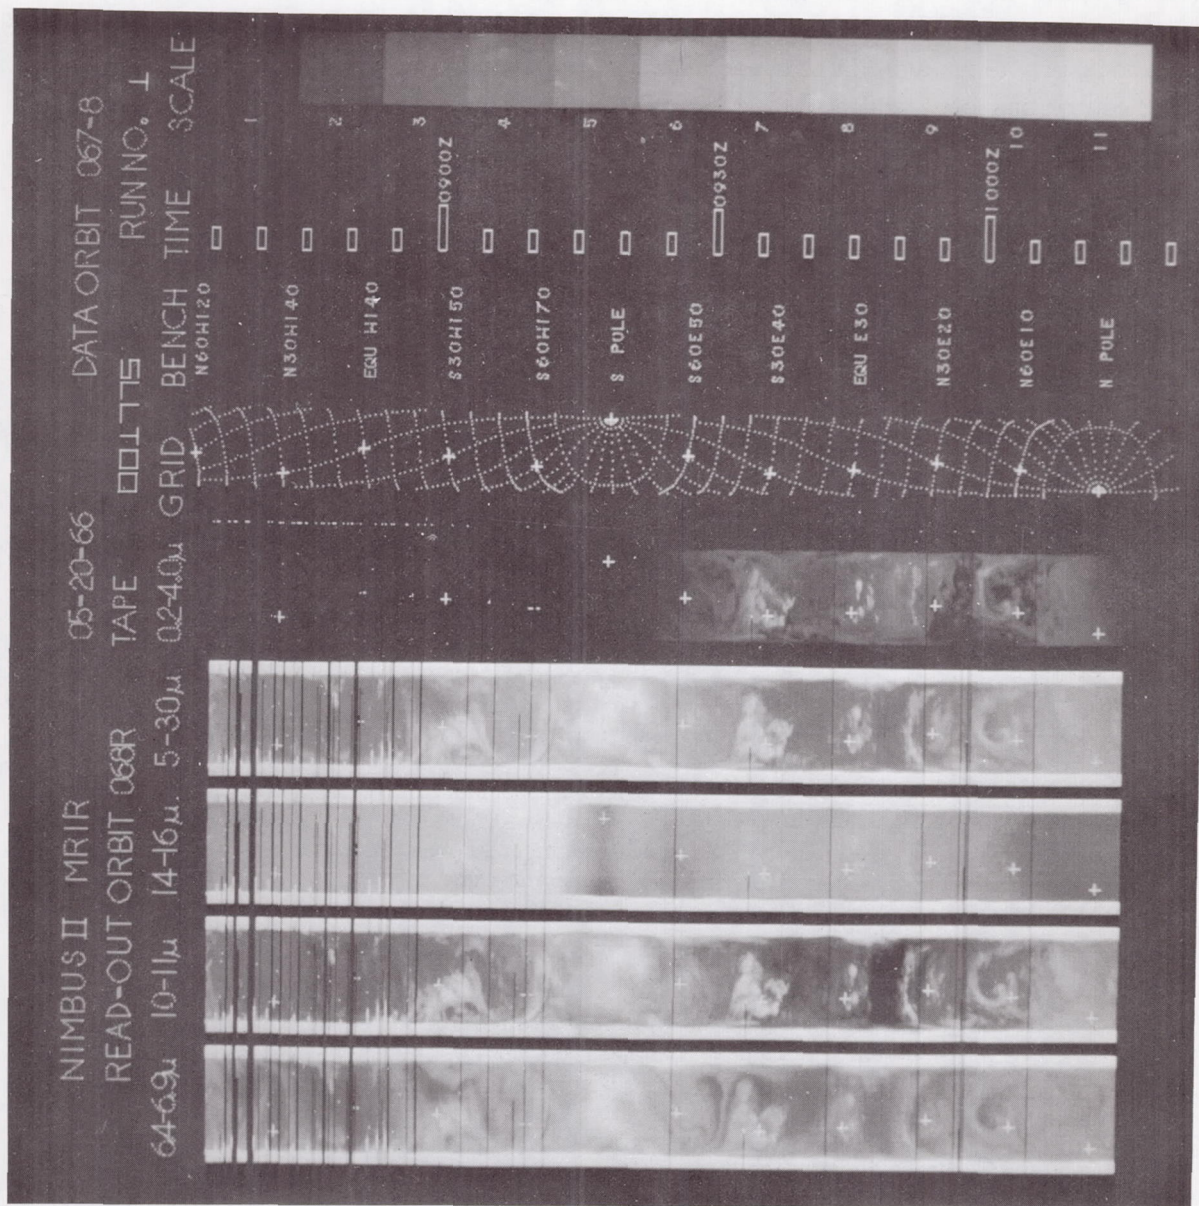
Figure 12-5—MRIR video showing sunlight effects at South Pole region and interference sync losses.
